AA-963

"A" Building

Crownsville Hospital Center

Maryland Historical Trust State Historic Sites Inventory Form

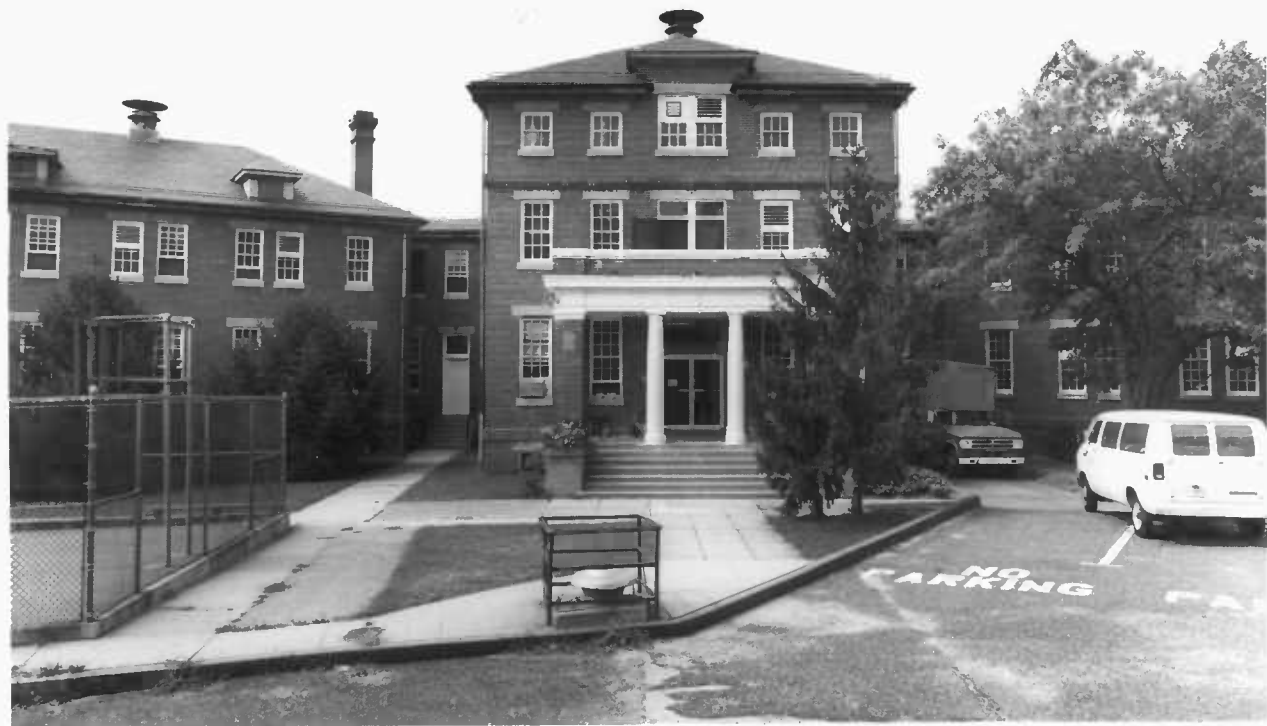
East

The east facade of the central block display many features which appear throughout the building. The ground level openings are characterized by concrete vertical joint lintels, wooden sills, and casement windows. A wide brick water table divides the foundation from the first floor. The windows on the first first, second, and third floors display concrete lintels and sills but the sash size decreases on each level from a 9/9 to a 3/3. A brick string course divides the second and third floors. The concrete cornice is interrupted by a false wall dormer. Both the reduced-sized dormer and the central block exhibit slate covered, hipped roofs.

A one-story portico also details the central block. A developed concrete entablature is supported by two brick pillars and two concrete columns. The columns have only minor detailing. Projecting from the flat roof is a brick railing with a concrete capstone which encloses the roof. The portico encompasses three bays of the five bay facade.

The east faces of the angled wings display minor changes. The outside three bays of each wing project slightly to form pavilions. Though retaining the same features, the windows on the wings appear in doubles. Single hipped dormers project from the roof and repeat similar features like concrete sills and lintels, hipped roofs, and single sashes. The angled wings also display interior brick chimneys.

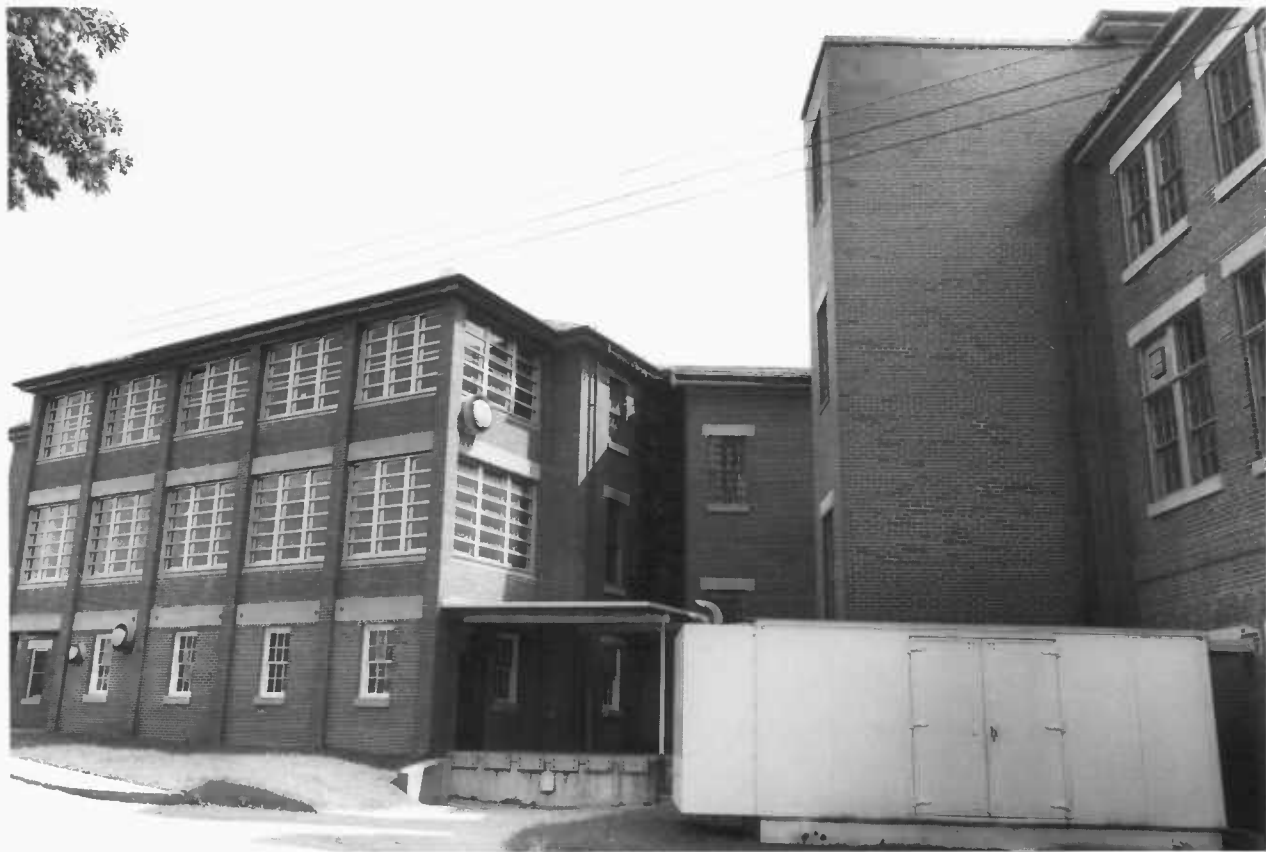
West

The west walls of the angled wings reveal a five bay addition which was added to provide the male and female wards with sun porches. The additions were designed by Henry Powell Hopkins and constructed in 1922. The additions have large single window openings capped by concrete lintels and punctuated by brick pilasters. The two story additions display modern replacement windows, flat roofs, and concrete cornices.

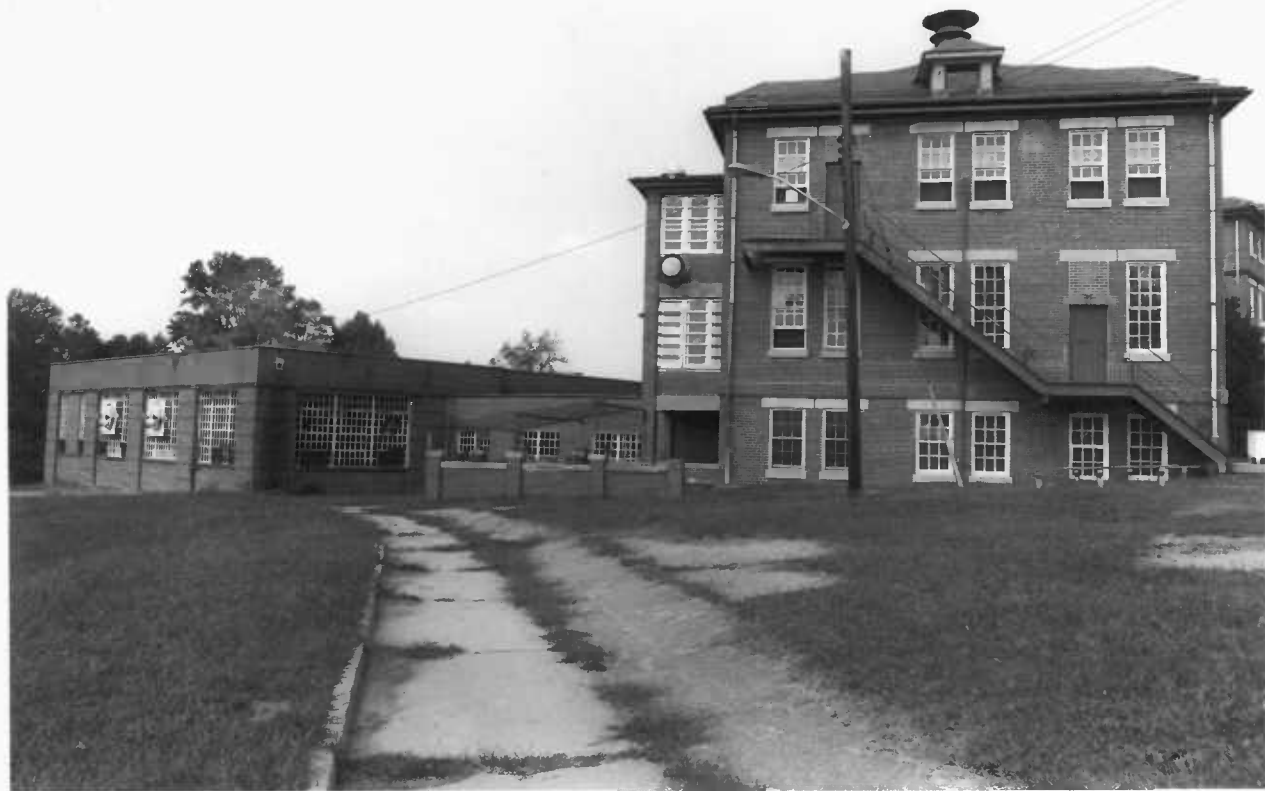
SOUTH

"A" Building and Laundry Building
